CASE STUDY

Diagnosing a low-speed gearbox problem

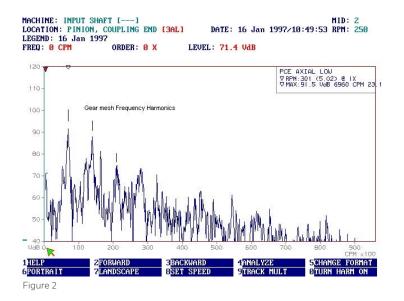
SymphonyAl Industrial was called on to help in the diagnosis of a suspected gearbox problem in a large plant connected with the paper industry. The gearbox in question had an input shaft with a 23-tooth pinion driving a large bull gear with 132 teeth which in turn drives another bull gear of the same size. The two gears are connected to large steel rollers about 24 inches in diameter. The two output gears turn at 52 RPM and the pinion turns at 302 RPM. See figure 1 below:

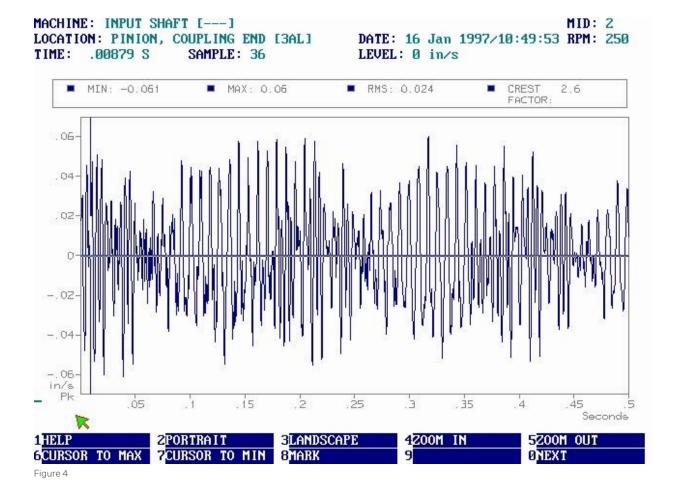
When we did synchronous averaging on each of the two bull gears, there was no indication of any defect in the waveform. But, when we performed the same test on the pinion, the waveform told another story. There was an obvious area on the gear where the meshing with the bull gear was very noisy and non-uniform. See figure 4, on the next page.

On looking at this data, we called for an inspection of the gear, but the maintenance chief was skeptical, saying that gearboxes with more vibration that this one had run for 20 years without any problems. But we insisted, and finally an access plate was removed so we could look at the gears. We found that the keyway in the pinion shaft was badly worn such that the gear could be rotated back and forth on the shaft by about 1/2 tooth at the edge of the gear. There was also visible clearance between the shaft and the bore of the pinion. The bull gears showed no sign of damage.

We called one of the engineers at the gearbox factory and described the situation. He said the problem occurred during installation when the interference fit between the pinion and the shaft was too loose. He said the shaft and pinion would have to be replaced, and very soon, to avoid a catastrophic failure. This made believers out of the maintenance people who originally thought the gearbox need not be overhauled. From that time on, the vibration monitoring program at this plant has enjoyed a much increased popularity and respect.
