CASE STUDY

Diagnosing a low-speed gearbox problem

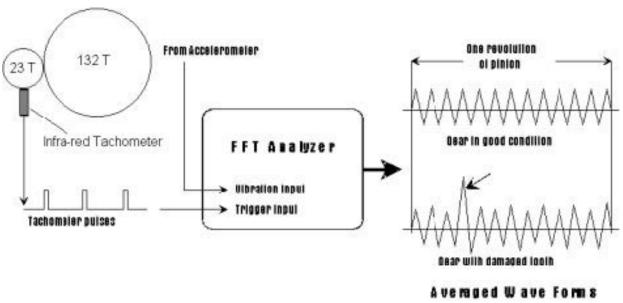
Figure 3

When using synchronous averaging, the number of averages used must be quite large; usually in the vicinity of 100 or so. For the tests described here, we used 90 averages. See figure 3 below for the setup details:
